Gear Inspection:

Troubleshooting Tips

YOU INSPECT YOUR GEARS TO MAKE SURE YOU'RE PRODUCING THE BEST PRODUCT YOU POSSIBLY CAN. SHOULD YOU DETECT A PROBLEM, THIS CHECKLIST WILL HELP YOU QUICKLY DETERMINE THE SOURCE.

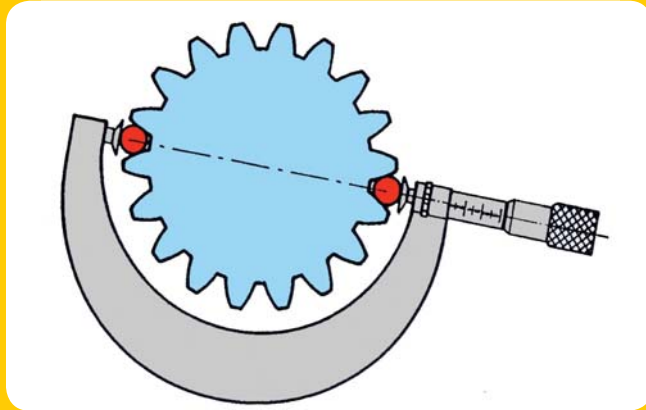
During gear hobbing the size of a gear is measured throughout the production run as a process control by the operator. As shown in Figure 1, this measurement is normally done using balls or pins of a specified diameter to contact the gear tooth profile at the pitch diameter. For larger gears a span measurement over several gear teeth will be done.

Figure 1: Measurement over pins

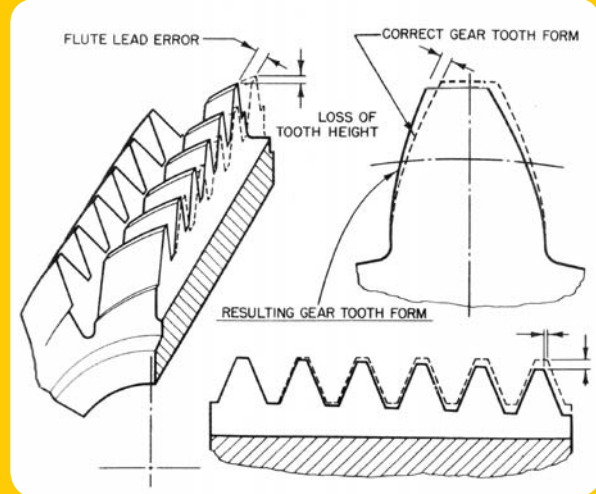
and this system may have failed.
2) Size changes during hob shifting. Check that the cutter has been properly sharpened without gash lead error. Due to the cam relief in a hob, any gash lead error will create a conical shaped hob. This will cause a size change in the part as the hob is shifted from one end to the other. The gash lead error will be approximately 2.5 times the taper error. Measuring the outside diameter of the hob at several points across the face is a quick way to determine if gash lead error is present.

Figure 2: Hob gash lead error

- 1) Incorrect hob sharpening. A hob sharpened with gash lead error will cause both a leaning profile and size change as the hob is shifted. See Figure 2.
- 2) Loose hob head swivel on the hobbing machine.

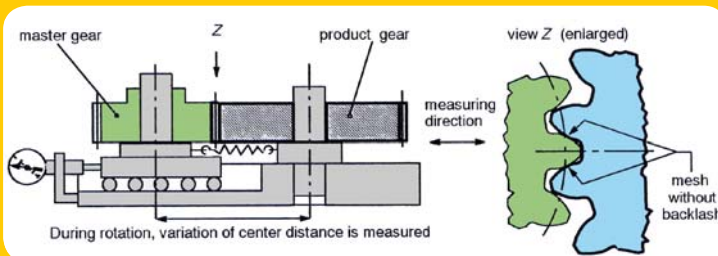
During gear hobbing a composite inspection is normally conducted throughout the production run as a process control by the operator. This is accomplished on a simple rolling machine using a master gear with the product gear.

Figure 3: Schematic of gear rolling process

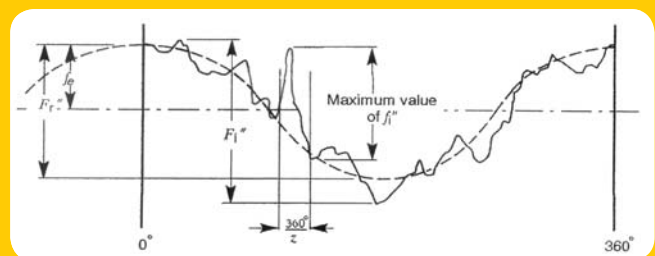
Composite error will occur as two conditions. First as a tooth-to-tooth error, and second as a once per revolution error of the test gear. The once per revolution error is commonly known as TCE, Total Composite Error, and is defined by the AGMA as the Radial Composite Variation.

Figure 4: Graphical record from composite inspection

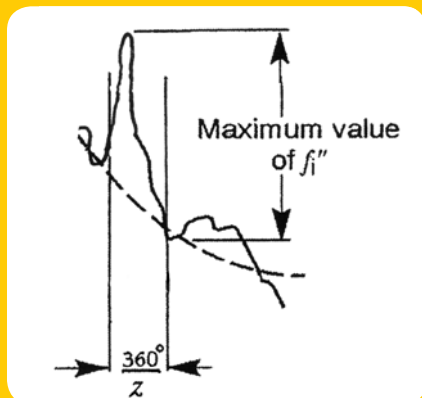
- 1) The large f_i'' is typically a dirty condition or a nick on a gear tooth. Nicks are normally caused by material handling problems. Adding a tip chamfer to the design of the gear tooth profile, and hob, will reduce this type of damage.

Figure 5: Dirty or nicked tooth on gear

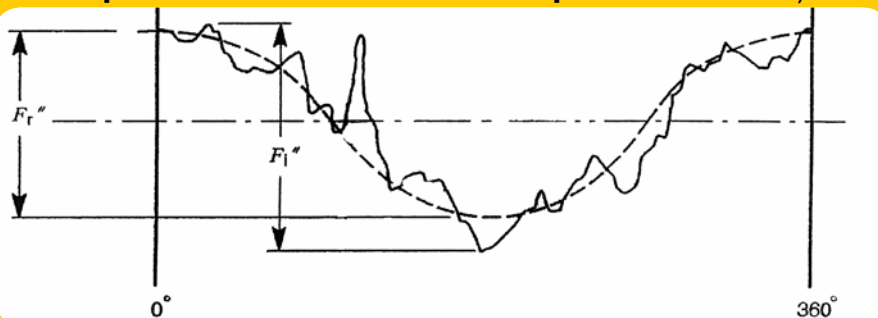
Figure 6: Total composite variation, F_i''

- 1) The work piece blank has radial runout or the blank has face wobble, resulting in excessive axial runout.
- 2) The work piece mounting fixture has radial or axial runout.
- 3) The gear teeth have excessive lead variation.
- 4) The hobbing machine work spindle or index drive system is worn or has runout.

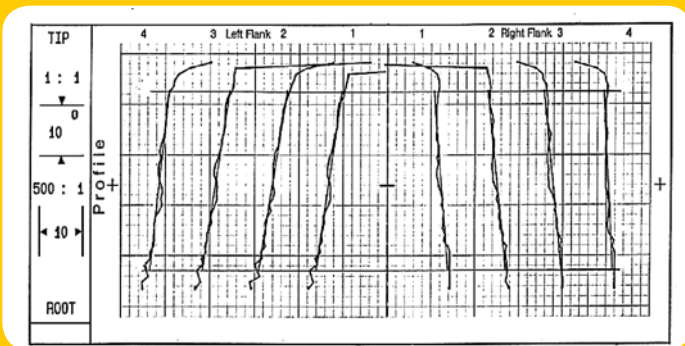
Figure 7: Profile inspection with negative tip tooth

1) Incorrect hob sharpening. The hob has been sharpened with positive rake error making the hob tooth larger toward the outside diameter and the gear tooth smaller.

2) Incorrect swivel angle setting on the hobbing machine.
3) Bad hob.

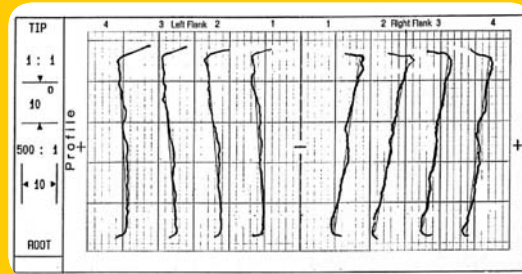
Figure 9: Profile inspection with positive tip

- 1) Incorrect hob sharpening. The hob has been sharpened with negative rake error, making the hob tooth smaller toward the outside diameter with gear tooth larger. This is the opposite of the condition shown in Figure 8.
- 2) Incorrect swivel angle setting on the hobbing machine.
- 3) Bad hob.

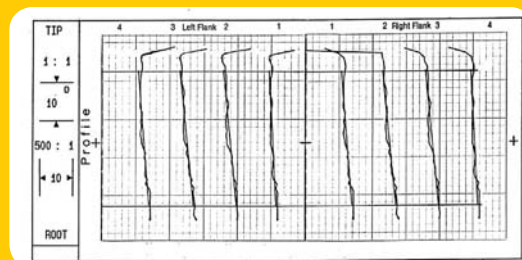
Figure 10: Profile inspection with leaning teeth

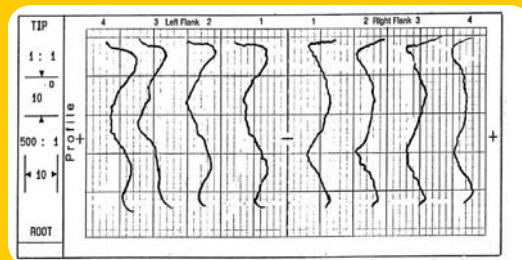
Figure 11: Profile inspection with uniform wave

- 1) Hob had runout when mounted. The hob runout can be caused by a bad cutter, damaged arbor, or dirty mounting conditions.
- 2) Incorrect hob sharpening. The hob was sharpened with runout during the mounting on the sharpening machine or sharpening

arbor. Extreme gash to gash spacing error on the hob.

- 3) A loose or worn hob arbor end support on the hobbing machine.
- 4) Excessive backlash in the hob spindle system on the hobbing machine.
- 5) Excessive backlash in the work spindle system on the hobbing machine.

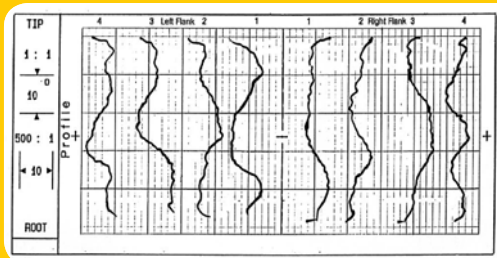
Figure 12: Profile inspection with non-uniform wave

- 1) A loose or worn hob arbor end support on the hobbing machine.
- 2) Excessive backlash in the hob spindle system on the hobbing machine.
- 3) Excessive backlash in the work spindle system on the hobbing machine.
- 4) Hobbing machine system in poor overall condition.

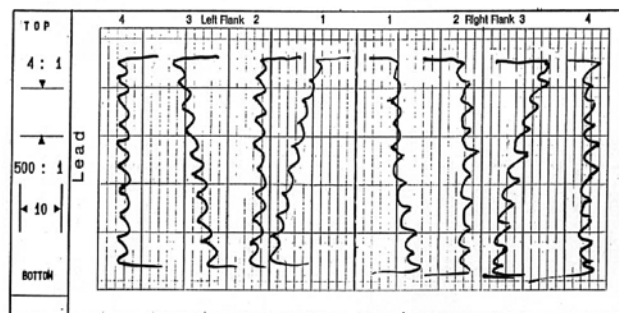
Figure 13: Helix inspection with wobble

- 1) Part blank bore not perpendicular to the face of the blank.
- 2) Part blank faces not parallel.
- 3) Fixture not accurate, or misaligned.
- 4) Tailstock misaligned, or center loose or damaged on the hobbing machine.
- 5) Inspection arbor problem.
- 6) Worm spindle bearing problem on the hobbing machine.

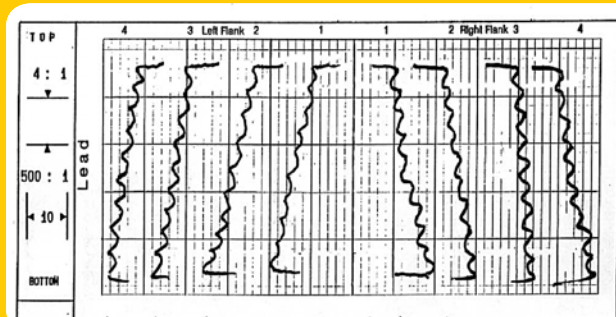
Figure 14: Helix inspection with taper

- 1) Tailstock misaligned on the hobbing machine.
- 2) Hobbing machine misaligned.

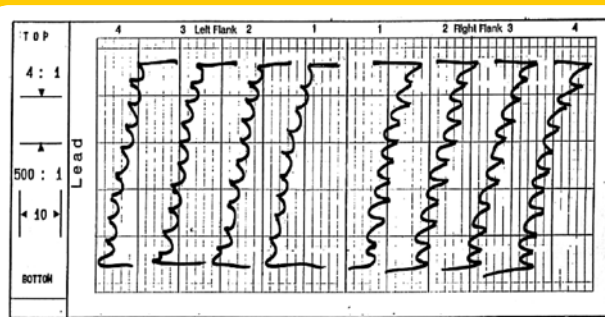
Figure 15: Helix inspection with angular error

- 1) Tailstock misaligned on the hobbing machine.
- 2) Hobbing machine misaligned.
- 3) Incorrect differential change gears or helix value (CNC).
- 4) Loose or work hob arbor end support on the hobbing machine.
- 5) Incorrect helix checking machine settings.

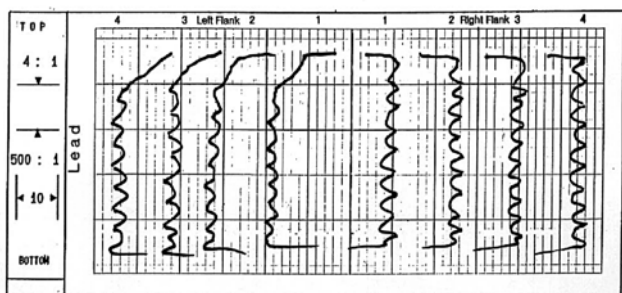
Figure 16: Helix inspection with breakout error

- 1) Tailstock loose or worn.
- 2) Part slipped in the fixture.
- 3) Fixture not clamped properly.
- 4) Hob arbor end support improperly installed or worn on the hobbing machine.
- 5) Hob saddle gibs out of adjustment.
- 6) Backlash in the cutter spindle drive system on the hobbing machine.
- 7) Backlash in the work spindle drive system on the hobbing machine.

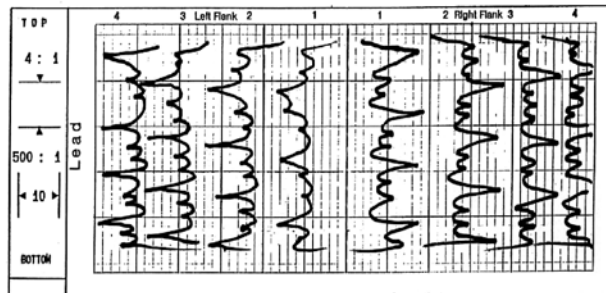
Figure 17: Helix inspection with periodic error

- 1) Runout of multiple thread hob.
- 2) Thread to thread spacing error on multiple thread hob.
- 3) Feed screw or bearings of the feed screw on the hobbing machine.
